TECHNICAL REPORT

THE GLACIAL LAKE HANDBOOK

REDUCING RISK FROM DANGEROUS GLACIAL LAKES IN THE CORDILLERA BLANCA, PERU

February 2014

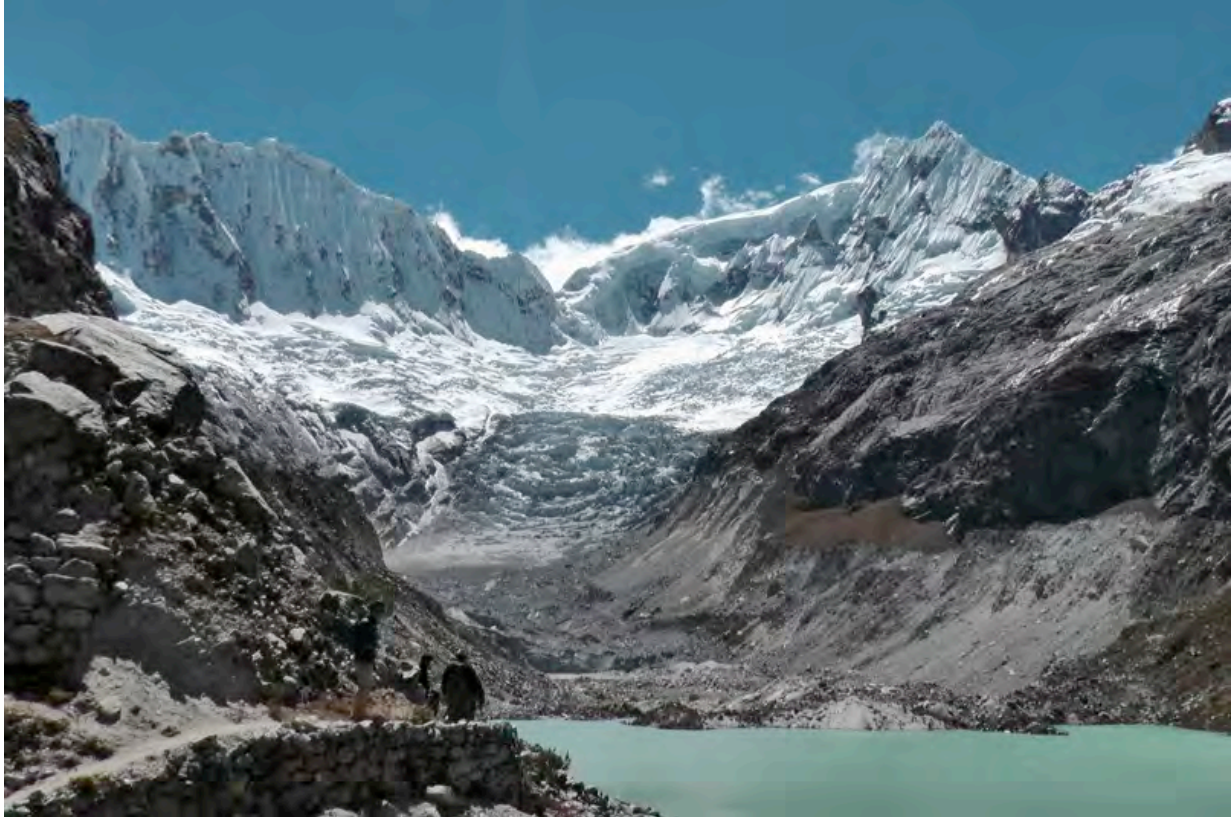
Llaca Lake, Huascarán National Park, Peru, is dominated by ice-covered peaks. Large hanging glaciers suspend from the shoulder of the peak on the right (Ranrapalca, 6,162 meters). Flatter, thicker glaciers lie below. As the glacial tongue retreats, it leaves Llaca Lake where the glacier used to be. Large icefalls from the tops of these peaks are capable of reaching the lake.
Photo: John Harlin

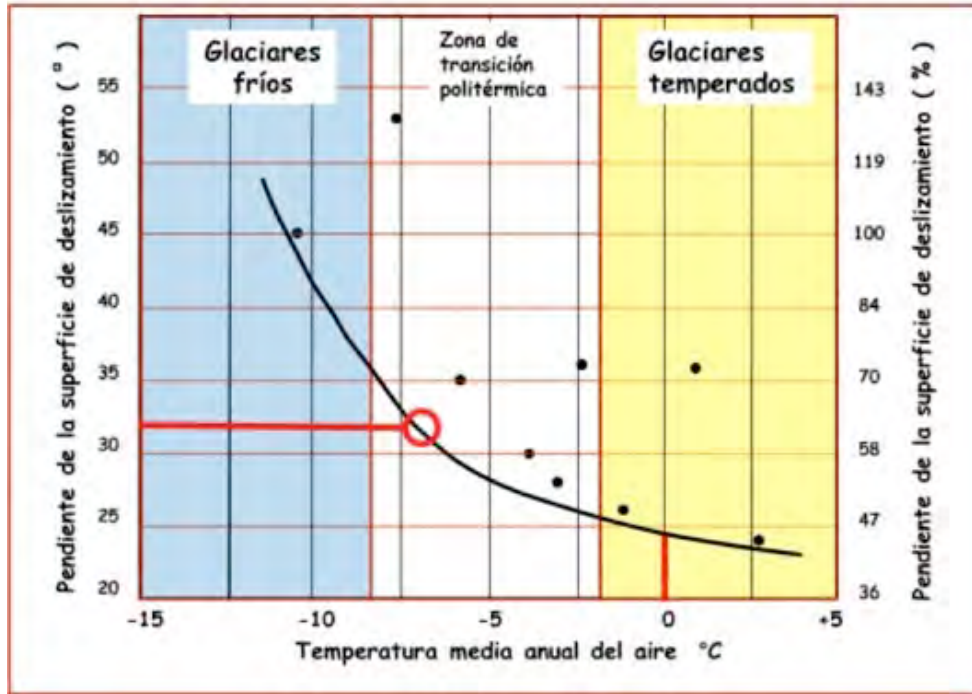
Figure 3-1 Critical Slopes for Different Types of Tropical and High Latitude Glaciers. Vertical axis: Slippage surface gradient. Three categories: cold glaciers, polythermal transition zone, temperate glaciers. Horizontal axis: Average annual air temperature. Source: Institute of Geography of the University of Zurich

Slope is an important factor in determining the potential of avalanche debris falling into glacial lakes. The slope is used in calculating glacier stability and the probability of failure from edge effects or ramp type. Scientists at the University of Zurich have developed empirical relationships based on glacier studies in the Alps that help to determine the slope at which slippage might occur depending on temperature. This relationship allows slope measurements from satellite imagery and digital elevation models to be used in determining the potential of a flood event. For example, a 25-degree gradient might lead to sliding of warm glaciers in Peru, whereas the same gradient might not lead to sliding in the cold environments of high-latitude glaciers. Adhesion of the ice to underlying bedrock is highly dependent on ambient air temperature. Good examples include [Case Study 5.1: Lake Palcacocha](#) and [Case Study 5.3: Lake 513](#), both of which have bedrock slopes steeper than 30 degrees.

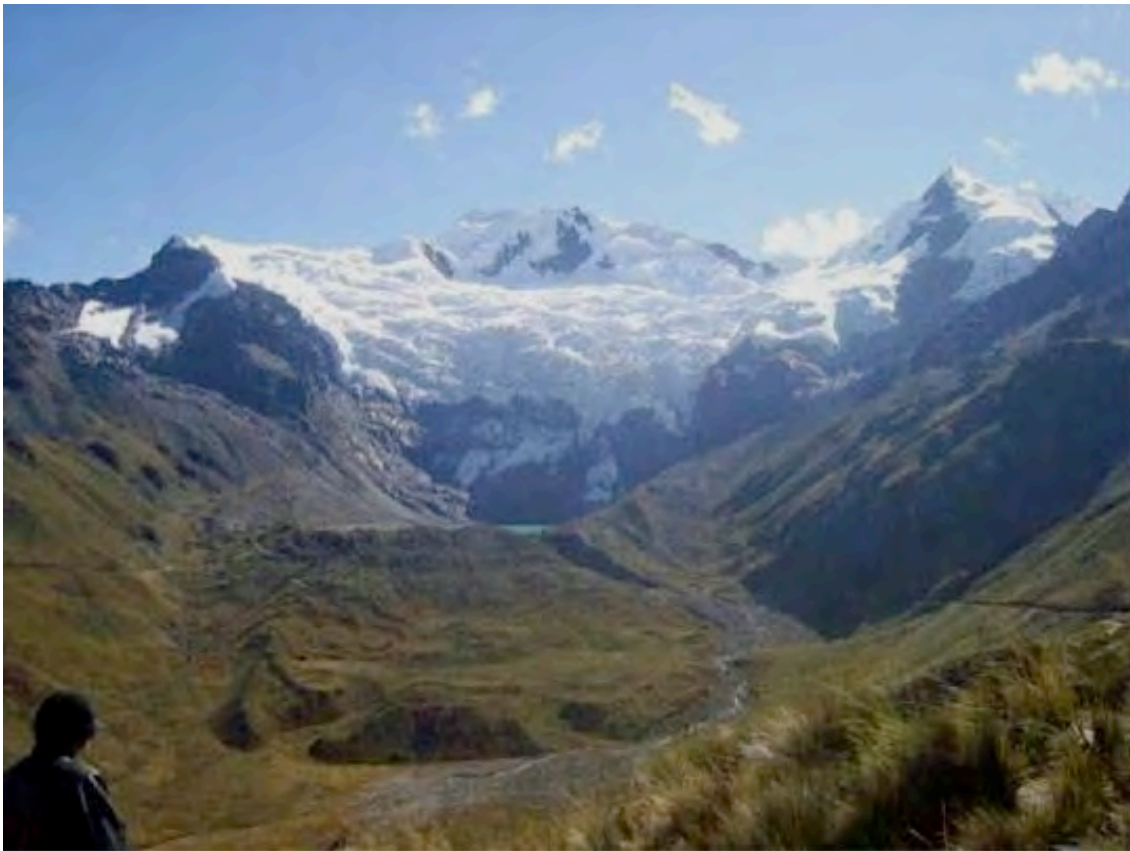
Large hanging glacier over Lazo Huntay Lake in the Cordillera Huaytapallana, in central Peru, 1990. Photo: César Portocarrero

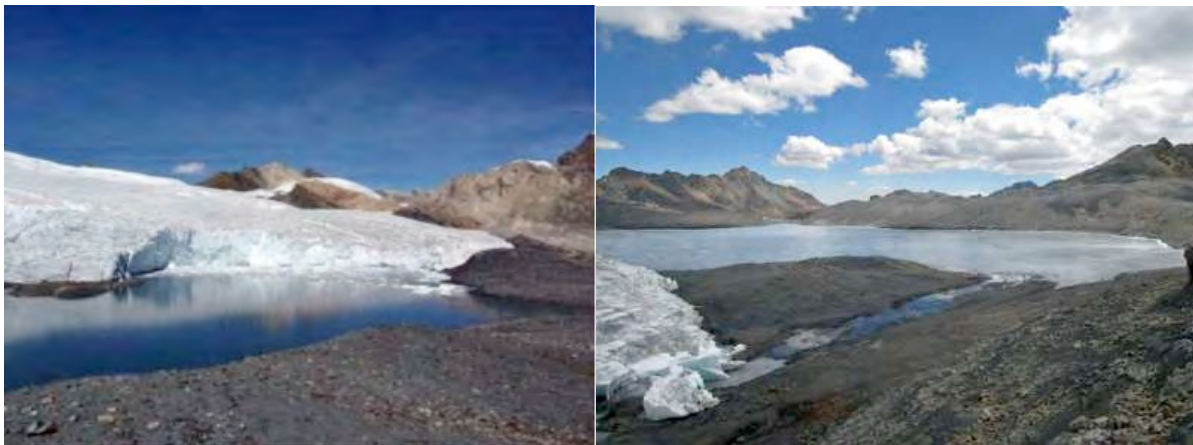
Pastoruri Glacier, Peru, in contact with an emerging lake, showing the calving process. Photos: César Portocarrero (left), Daene McKinney (right)

As glaciers retreat, it often leaves behind empty spaces that are gradually filled with meltwater and eventually form lakes. As these lakes are still in direct contact with the glacier tongue, the temperature difference between the water and the glacier produces an eroding effect that eventually causes the ice to break off and cascade into the lake. This can create a dangerous surge wave, depending on the mass of the ice and the volume and shape of the lake. This phenomenon has caused natural disasters in many places. Examples include the event in [Case Study 5.1: Palcacocha Lake](#), which flooded the city of Huaraz. Also in [Case Study 5.16: Lazo Huntay Lake](#), which flooded the town of Huancayo, and, more recently, in an unnamed lake at the foot of the Nevado Chicón (see [Case Study 5.17: Riticocha Lake](#)).

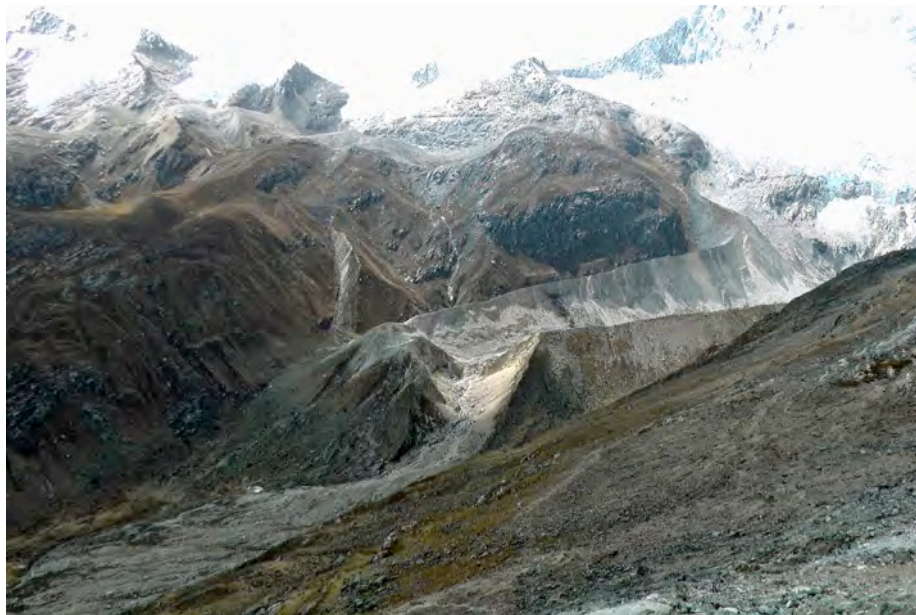
The terminal and lateral moraines that contain Palcacocha Lake, showing the 1941 breach that released a GLOF that devastated the city of Huaraz. Photo taken in 2013. Photo: John Harlin

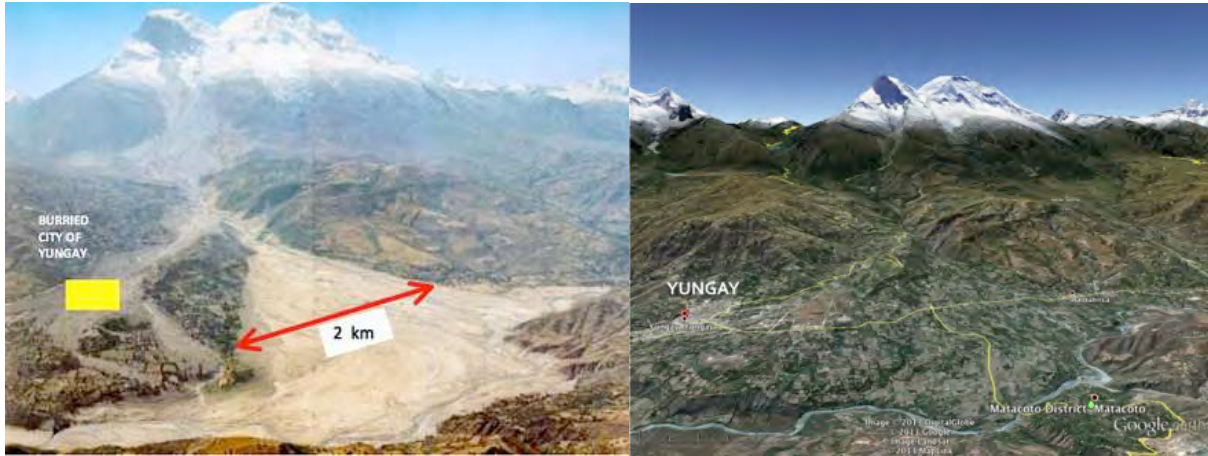
Left: Nevado Huascarán in May 1970 after a 7.9 magnitude earthquake triggered a massive avalanche from the north peak that turned into a debris flood. Approximately 6,000 people are believed to have died in the flood. Photo: Walter Welch. Right: A Google Earth view of Yungay and Huascarán in 2013. Many homes have been built on the debris of the 1970 flood.

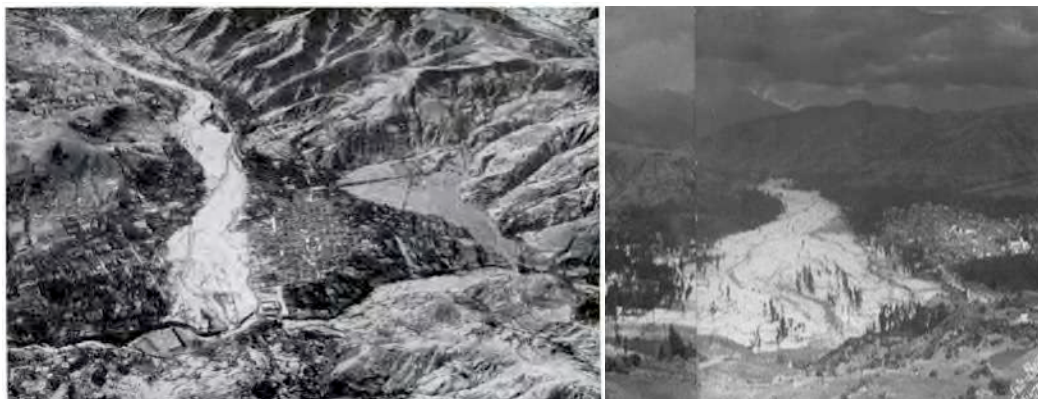
The GLOF's destructive path through the city of Huaraz in 1941. Servicio Aerofotográfico Nacional del Perú

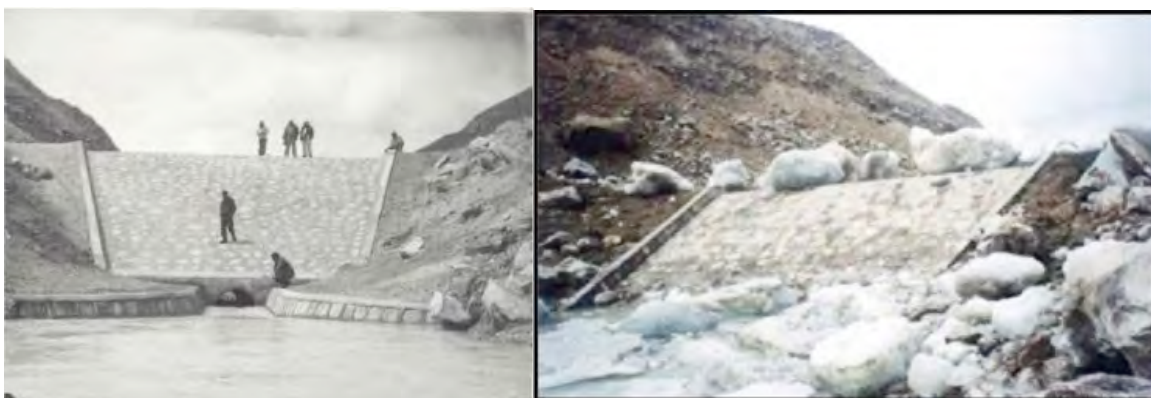
The safety dam on Palcacocha Lake as construction was being completed in 1974 (left) and with ice debris following the 2003 landslide that launched a flood that was mostly contained by the dam. Left photo: César Portocarrero. Right: Glaciology Unit Office Archives

At that time the Lakes Safety and Glaciology Unit decided to lower the lake's level by one meter, which they concluded was enough based on its low volume of 500,000 m³. In 1974, they installed a 48 inches (1,219 millimeters) diameter steel pipe capped by a new, tightly compacted dirt dam 8 meters high. They also strengthened the right side of the moraine outflow to reduce erosion from outbursts. This provided a freeboard of 8 meters in the lake as a buffer against future surge waves.

Nineteen years later, in March 2003, the moraine along the lake's left flank slipped, launching a violent diagonal wave that traversed the lake and heavily eroded the reinforced dam. Photographs, taken five days after the 2003 event, show chunks of ice still sitting on the 8-meter dam, and water levels still 4 meters above its normal level. This event frightened the Huaraz city authorities. The regional government quickly repaired the damaged structures.

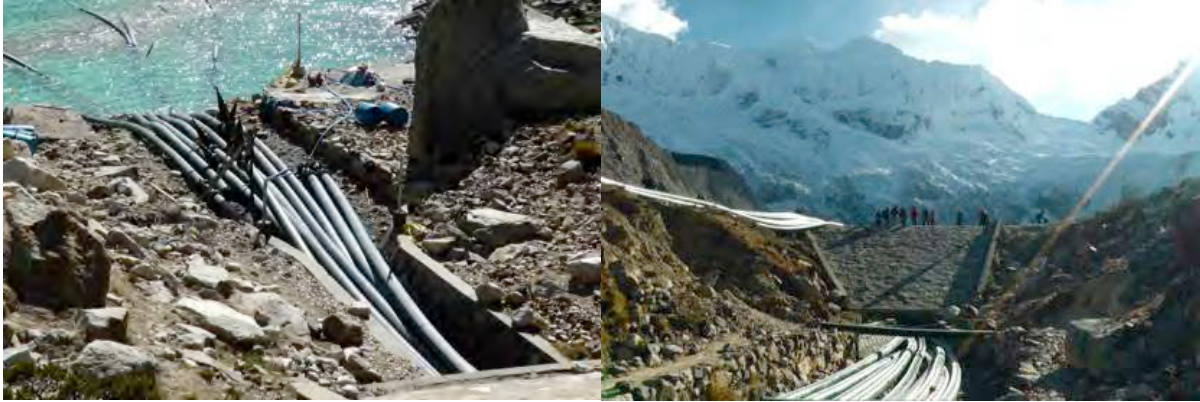
Palcacocha Lake in 2013 showing the siphon pipes entering (left) and exiting the tunnel under the dam. Photos: John Harlin

The Glaciology and Water Resources Unit prepared a plan in 2010 to lower the water level of Palcacocha Lake by an additional 15 meters. The cost estimate for this work came in at US\$4 million. Later in 2010, Peru's National Water Authority unexpectedly relieved the Glaciology and Water Resources Unit from responsibility for glacial lakes and turned the lake-lowering plan over to the regional government in Ancash. Ancash officials did not think they could authorize these funds quickly, so they searched for an interim, cheaper way to reduce risk from the lake. They decided to use six 10-inch(254 millimeters)-diameter pipes about 700 meters long to siphon off approximately 7 million cubic meters of water. Two years later (in 2011), the siphons started draining the lake though at a slower rate than planned due to design defects. As of July 2013, the water level had been lowered approximately 3 meters, roughly half the amount needed before the drainage ditch can be started.

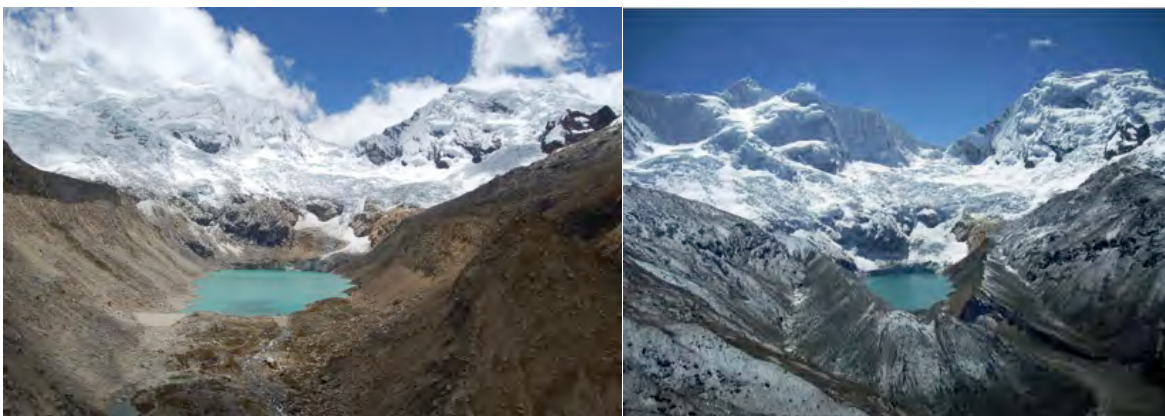
Left: Palcacocha Lake in 2013 taken from the top of the moraine. The two safety dams can be seen. The dam on the right contains the drainage pipes. Photo: César Portocarrero. Right: Palcacocha Lake in 2008 showing its enclosing moraine; the 1941 breach is visible in the lower right. Photo: Colette Simonds

In an effort to mitigate the risk of the lake, two 36 inches (915 millimeters) steel pipes were placed in the notch that had been cut into the moraine by the GLOF. Then, an 8-meter rammed earth dam was built over the top. These safety works continued working properly until the May 31, 1970, earthquake (magnitude 7.9) destroyed the dam's foundations, breaking the drainpipes installed underneath.

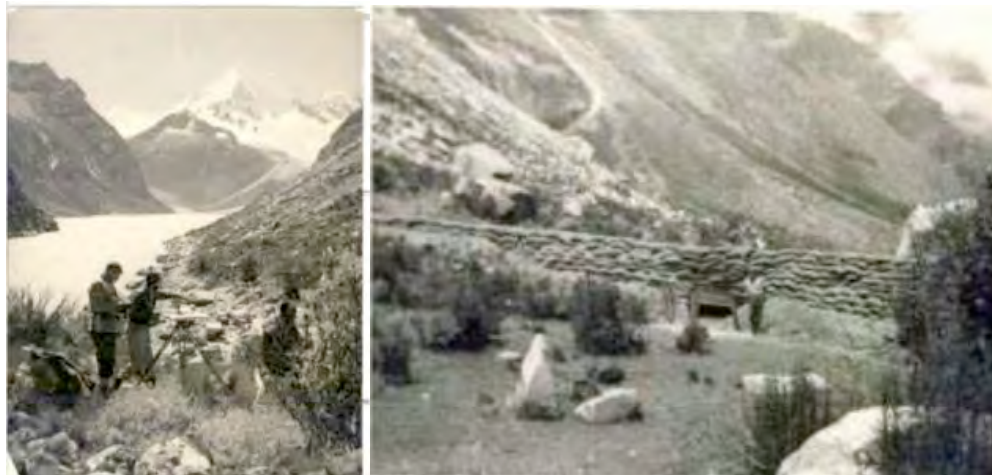
1951 photos of surveyors and a sand bag dam built as a temporary barrier below Lake Parón. Photos: Glaciology Unit Office Archives

Some safety measures were implemented after the 1951 outburst floods from Lake Artesoncocha including placing sand bags over the natural dam. Topographical studies examined lake characteristics for future drainage projects.

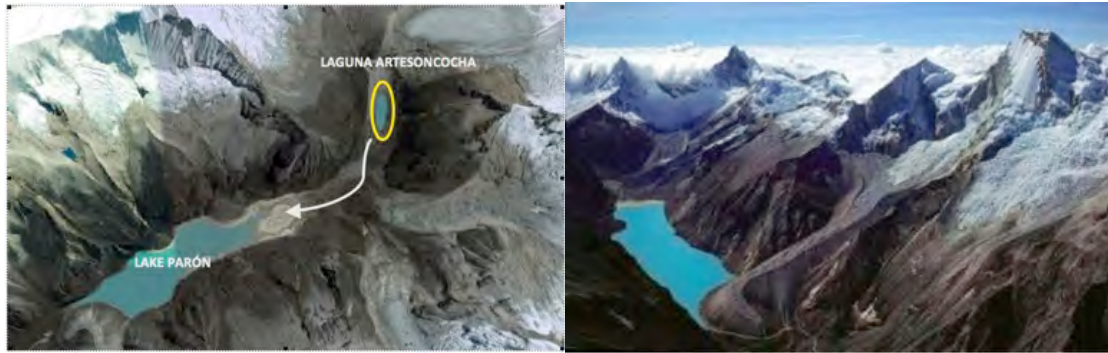
Left: The path taken by the 1951 outburst floods from Artesoncocha into Lake Parón. Google Earth imagery is from 2012. Right: Lake Parón showing the moraine descending from Huandoy that blocked the valley and created the lake. Photo: César Portocarrero

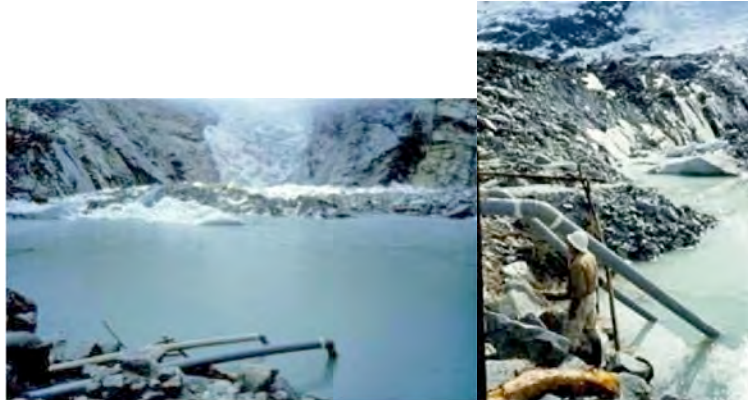
The initial siphoning process to lower the water level of Lake 513 in the late 1980s. Siphoning was an interim measure until funding was received for construction of the tunnel. Photos: César Portocarrero

The remoteness of the area and the lack of resources available for a major project led the Glaciology Unit to install temporary siphons in 1989 (with financial support from the British and Austrian governments). These plastic pipes, 10 inches (254 millimeters) and 12 inches (305 millimeters) in diameter, were used to lower the water level by about 6 meters. In 1992, drilling started for a tunnel that would lower the water level by 20 meters. The work was financed by the Peru's Civil Defense Institute.

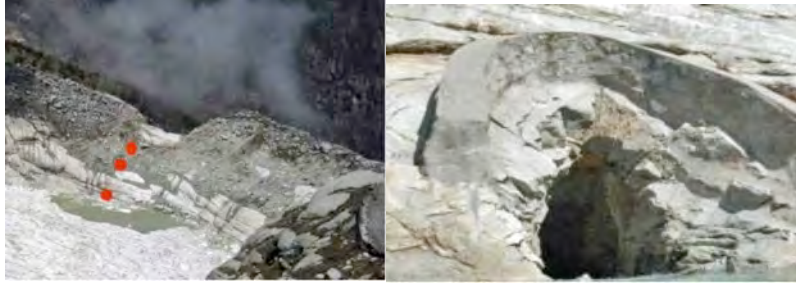
Red dots mark the tunnel entrances on Lake 513. The photo on the right shows the lowest entrance. Photos: César Portocarrero

The original plan was for the tunnel to contact the lake at a depth of 20 meters, using underwater blasting and placing devices inside the tunnel to regulate the outflow. However, this plan was abandoned during construction when the driller became afraid to blast the connection to the lake at such a depth. Instead, a sloping shaft was built from which connections would be added at increasing depths of 5, 10, 15, and 20 meters.

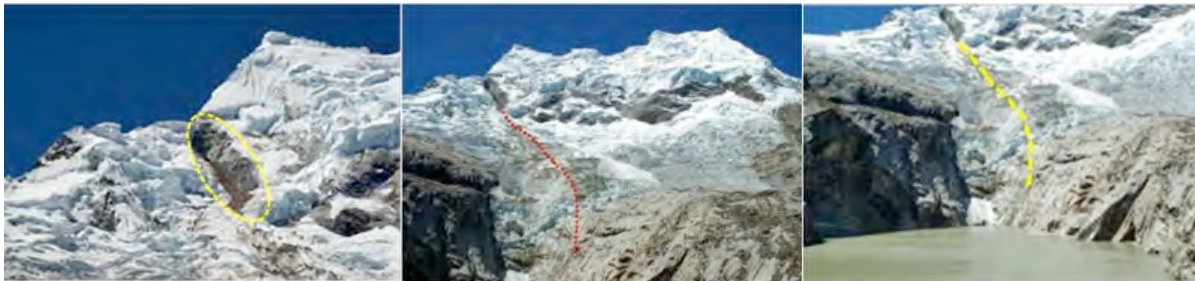
The source and path of the 2010 ice avalanche from Hualcán that fell into Lake 513. There is potential for many more such avalanches. Photos: César Portocarero

During the ensuing 18 years, the combined drainage tunnel and freeboard fulfilled the mission to regulate the flow produced by moderate avalanches from Mt. Hualcán. Then, on 11 April 2010, a very large avalanche, presumably in the 300,000 to 400,000 m³ range, caused a hydrodynamic surge and a wave higher than 20 meters that overflowed the works and flooded the Chucchun River for approximately 30 hours, destroying bridges, farmland, and houses.

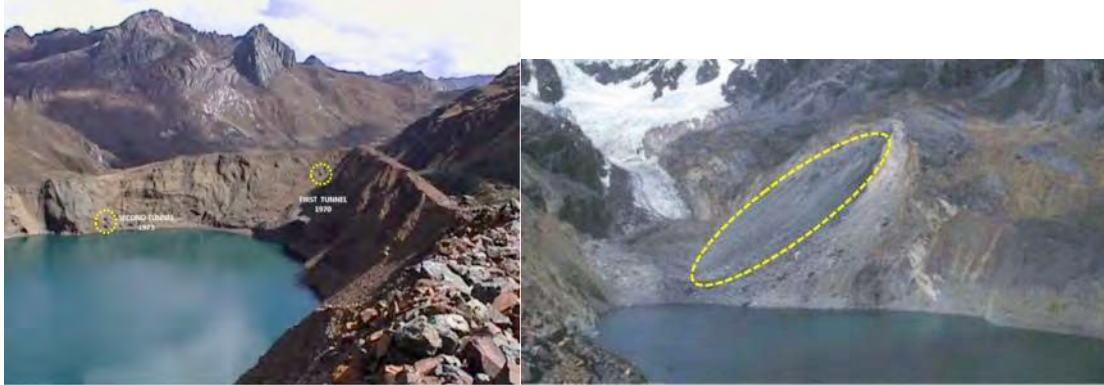
Safuna Alta Lake. Left: Locations of the two tunnels drilled into the moraine in the early 1970s as the lake's level dropped on its own. Right: The source of the landslide in 2002 that launched a wave at least 80 meters in height. Photos: César Portocarrero (1974)

History of work: In the early 1960s the Glaciology Unit recommended building a 47-meter-long drainage tunnel that would prevent the lake's water level from rising above 4,360 meters. In April 1970, a tunnel was completed that was supposed to reduce the water level by 38 meters (Ames and Francou, 1995). However, by then the water level had dropped by 30 meters, so that the tunnel was above the lake's new water level. A month later, a large earthquake severely damaged the tunnel. A new 159-meter-long tunnel was built that, like the previous tunnel, had to be excavated through morainic material. (Report of the Glaciology and Lake Control Office of the Corporation Peruana del Santa, 1972).

In 2002, a rockslide created a wave of at least 80 meters in height (Reynolds, 2003). The wave damaged both tunnels, but did not destroy the moraine.

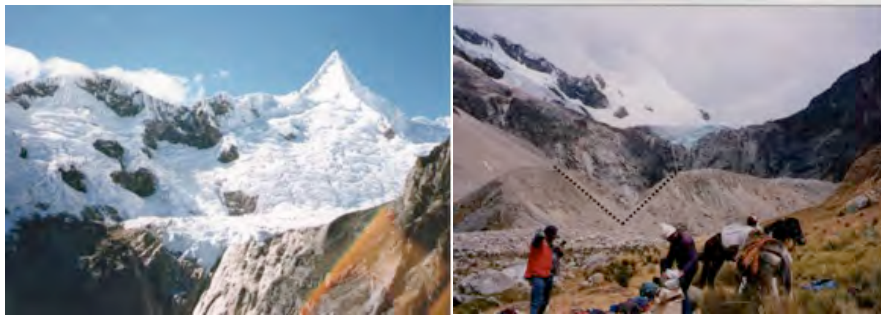
Left: Alpamayo Peak (5947 m), perhaps the most iconic peak of the Cordillera Blanca; Jancarurish Lake sits below the visible glacial tongue. Right: The V-shape cut into Jancarurish Lake's moraine in 1951. Photos: César Portocarrero (1990)

For unknown reasons, the head of the work team at Jancarurish Lake decided to leave the sand bags in place for four consecutive days. The height of the dammed water might have exceeded a meter by the time the sandbags were removed. The ensuing large flow of water eroded the moraine and emptied the lake in a GLOF.

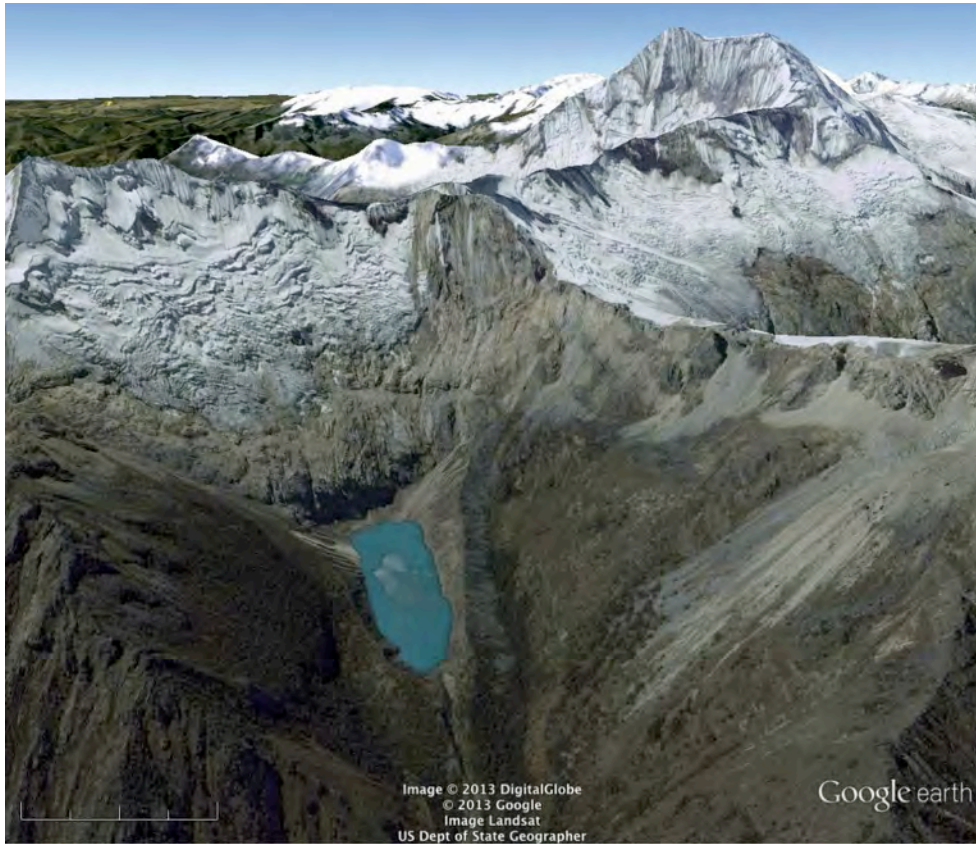
Huallecacocha Lake with its safety dam visible lower right.

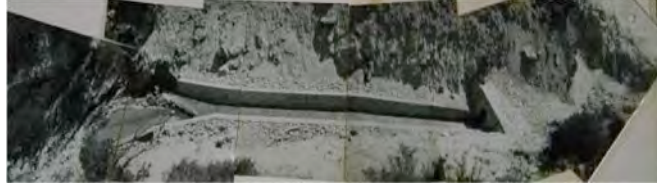
Safety works on Huallacocha Lake: 1950s construction (top) and the finished result in the 1960s. Photos: Glaciology Office Archives

History of work: This lake was treated twice. In the 1960s the former Control Bureau of Cordillera Blanca Lakes lowered its water level by 10 meters, and then built a sluice of stone masonry one square meter in cross section and 102 meters long. A 10-meter-high artificial dam, stabilized by riprap, was built on top of the structure.

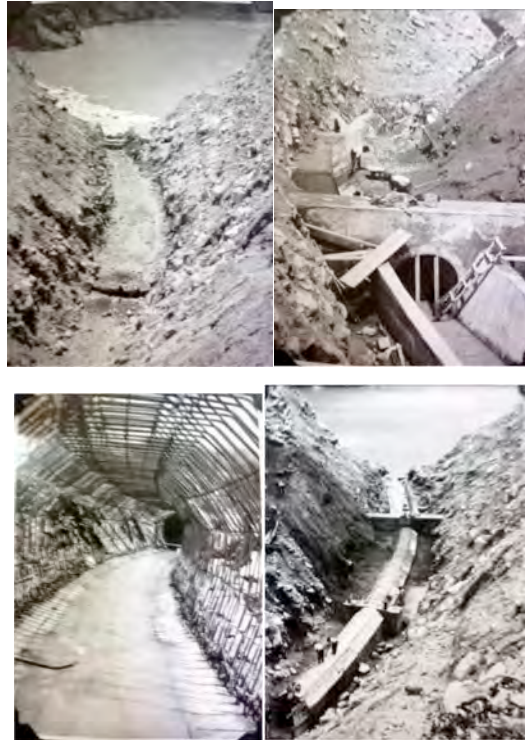
New tunnel being constructed in the early 1980s. First the channel was cut, then the tunnel built, and finally the canal was covered with a safety dam. Photos: César Portocarrero

New work following the 1970 earthquake required completely removing the original 20-year-old construction. The lake was then lowered by 14 meters through an open pit at the front of the moraine. The next phase involved building a reinforced concrete pipe 1.8 meters in diameter and 77 meters in

length. Inflow and outflow canals were built of stone masonry. To prevent soil erosion by water exiting the conduit at high velocity, a fast exit waterway of reinforced concrete and an energy sink were added. Finally, to contain potential surge waves resulting from ice masses falling into the lake, a 20-meter-high earth dam with an impervious waterproof core was added. The outside walls were finished with stone masonry sealed with cement mortar. During construction a mass of ice fell into the lake, but did not damage the work that was underway.

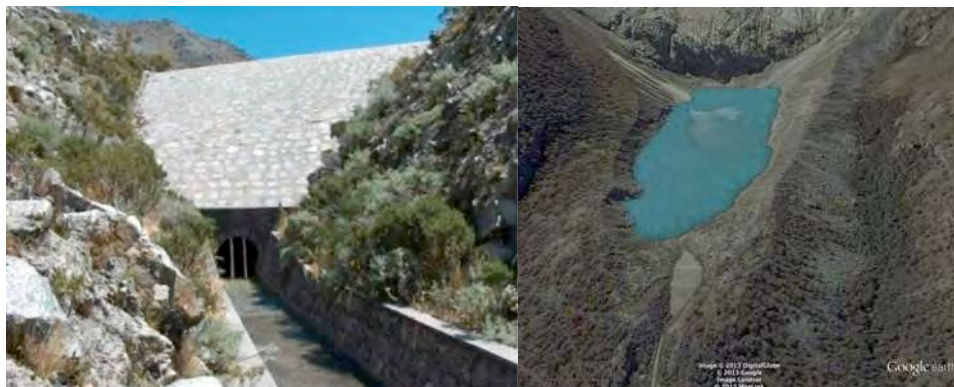
Huallacocha's completed safety dam from below (1978) and above (2013). Photo: César Portocarrero

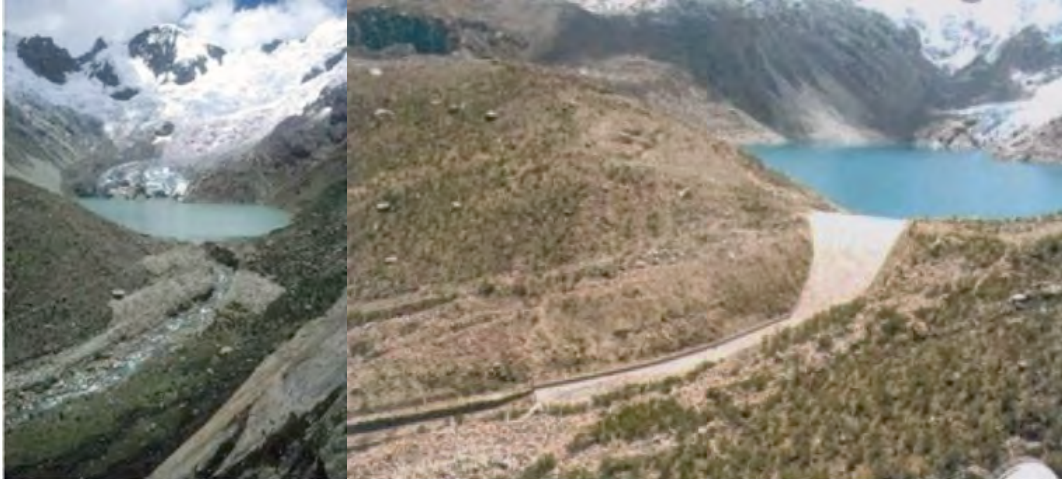
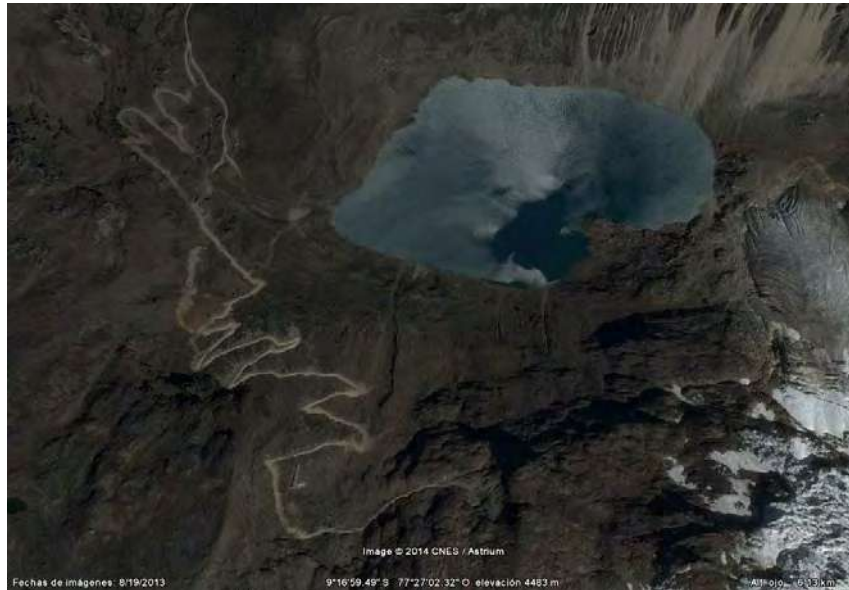
Paccharruri Lake showing the sluice cut to lower the water level (left) and the completed safety dam and outflow canal beyond the covered sluice. Photos: César Portocarrero

Work began in the early 1980s to lower the level of the water surface by 10 meters. A covered sluice 71 meters long and 1.8 meters in diameter was built, over which an 18-meter-high safety dam was added. As in other works of the same type, covered access and exit conduits were built to prevent erosion of the moraine material and safely move water downstream.

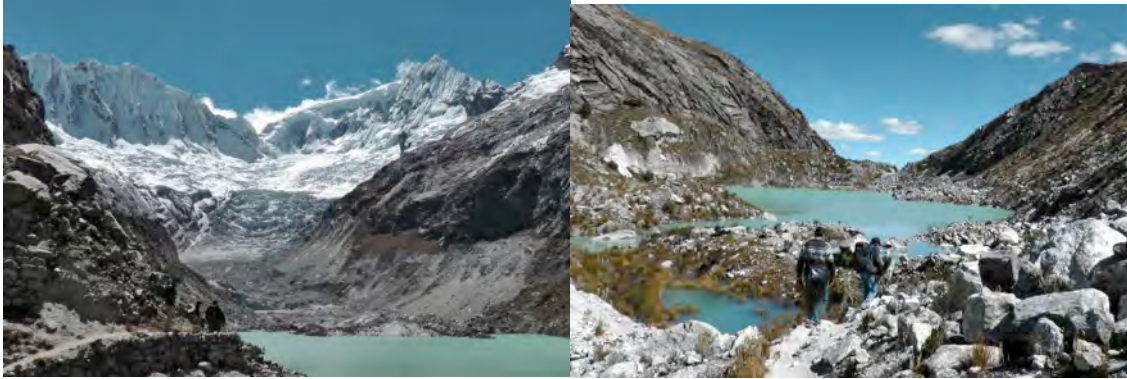
Left: Looking upstream from the safety dam at Llaca Lake. Right: The view downstream across Llaca Lake. Photos: John Harlin

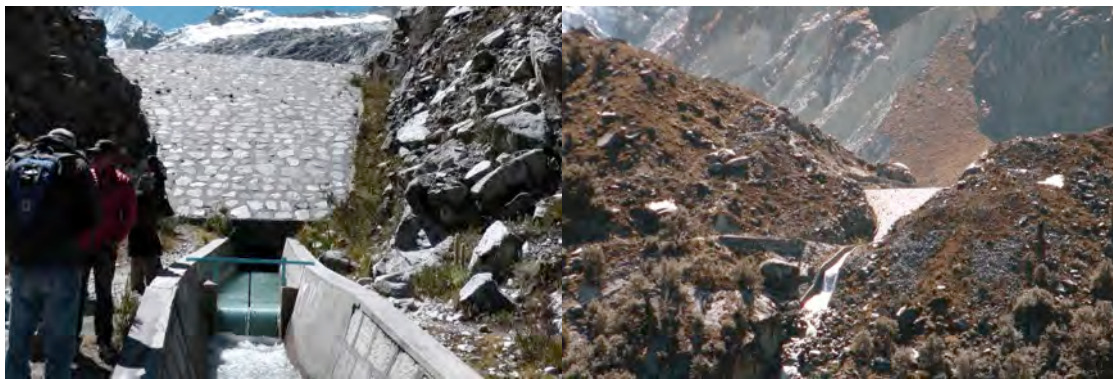
Llaca Lake's safety dam and sluice in 2013. Photos: John Harlin

History of work: First, steps were taken to improve access roads and camp sites. Once these improvements were finished, engineers lowered the lake by 10 meters through an open pit cut. After the lake was lowered, a 48-inch(1,219 millimeter)-diameter steel pipe was installed. When completed in 1974, the lake's maximum depth was 19 meters.

From 1976 to 1977, the second stage of the project involved building a 10-meter-high earth dam inside the open pit cut (on top of the steel pipes), with an impermeable core and stone walls finished with cement mortar-sealed joints.

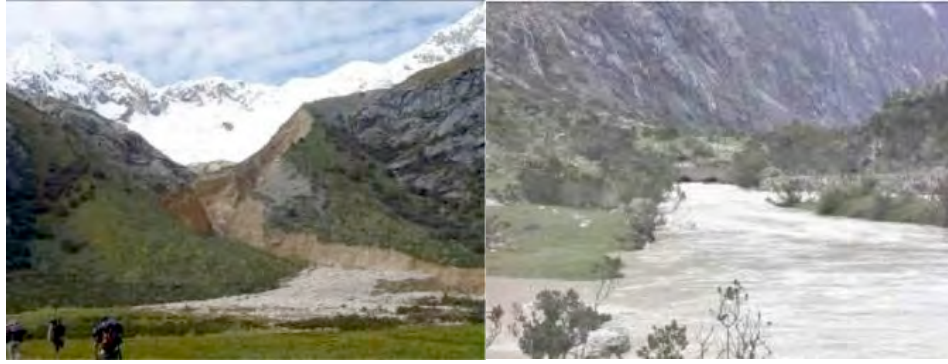
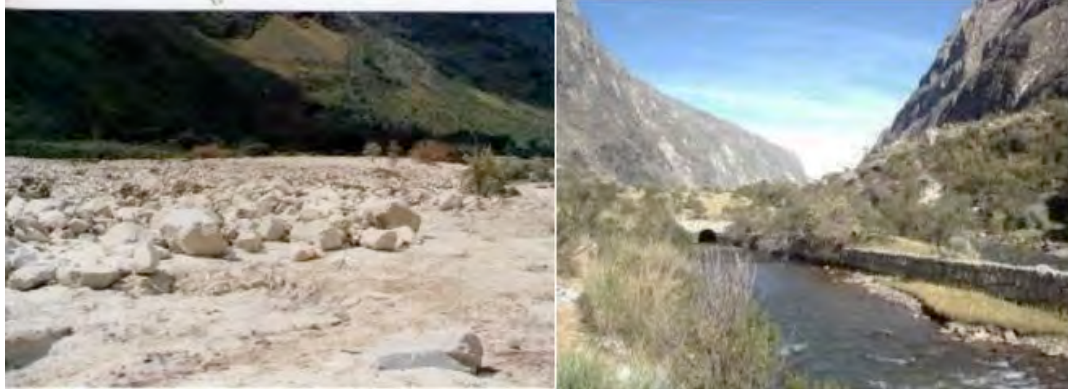
Top left: The path cut through Artizon Lake's moraine during its 2012 GLOF. Top right: Floodwaters resulting from Artizon's GLOF almost filled the drain pipes under Jatuncocha's dam. Bottom left: Debris from the 2012 Artizon GLOF. Bottom right: Relatively normal flows through the Jatuncocha tunnels. Photos: César Portocarrero

Although the Jatuncocha dam contained the flood, the flow through the two pipes reached more than 10 cubic meters per second down the steep valley below, causing substantial erosion and destruction of homes, property, and roads.

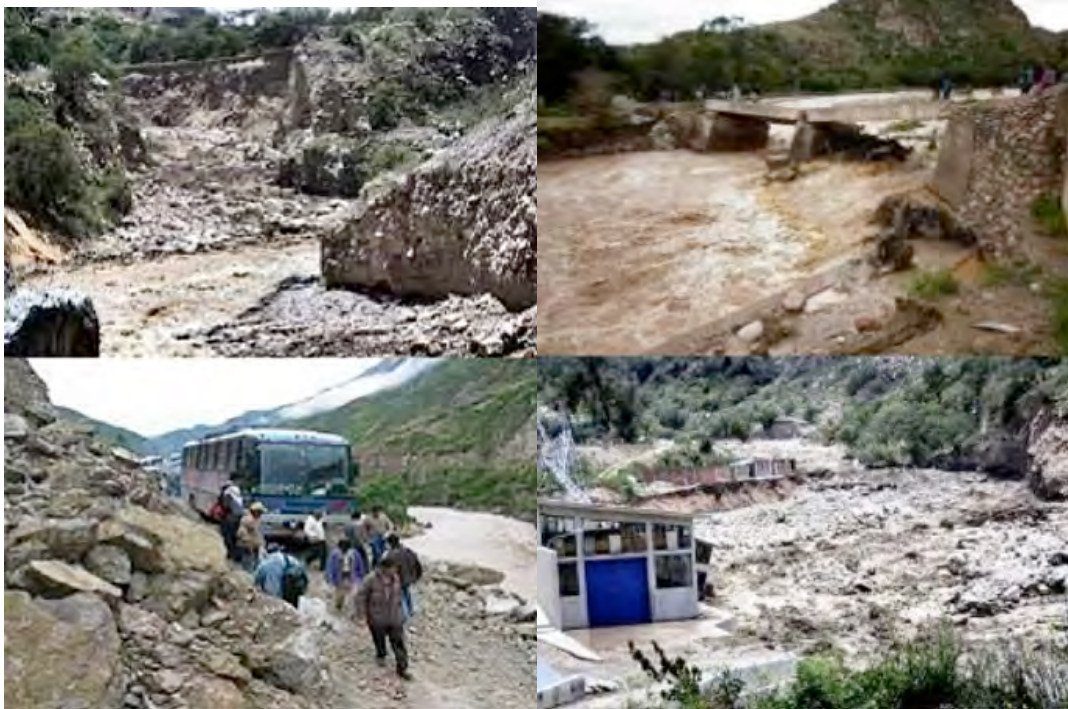
Damage in the Santa Cruz valley downstream from Jatuncocha during the 2012 GLOF. Photos: Hidroeléctrica Santa Cruz

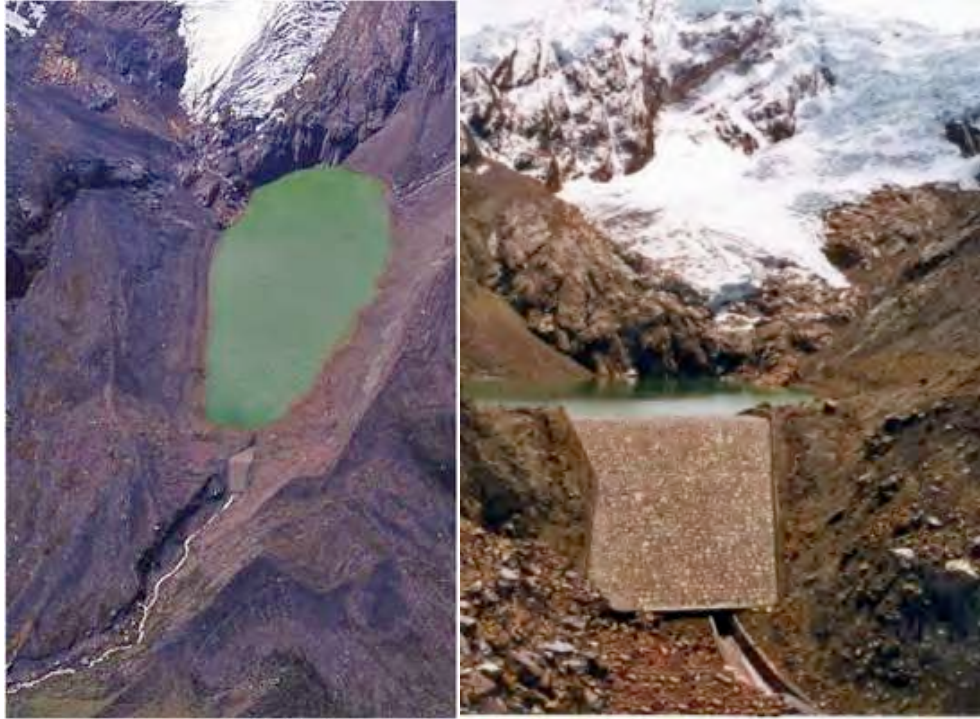
Aerial and ground views of Cuchillacocha Lake's dam, completed in 1974. Right photo: César Portocarrero

Given the low existing dam (4 meters tall), the Glaciology Unit built additional safety works. The first step was to lower the lake's surface level by 10 meters, which entailed evacuating about 1.6 million m³ of water. Next, they built a covered conduit and over it erected a 16-meter-high earth dam to contain future wave surges from ice avalanches. Inflow and outflow canals were added for the covered duct. In addition, they built bridle paths and semi-permanent camps for field workers. The work was completed in 1974.

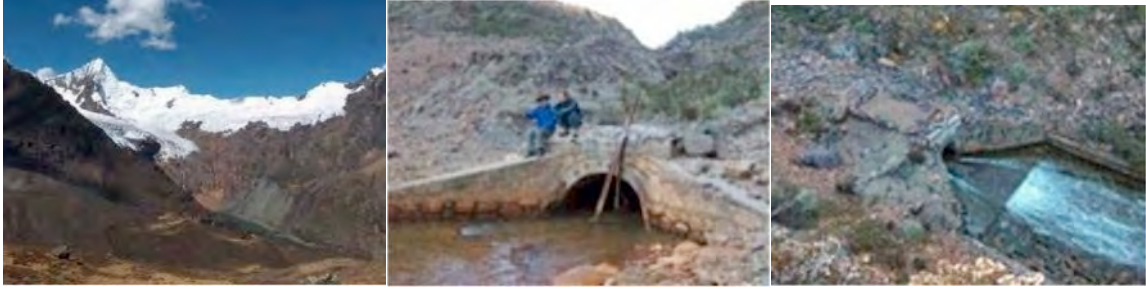
Tullparraju Lake showing its steep flanks and the hanging glacier above. Middle and right photos show the entrance and exit of the drainage tunnel. All photos from 1974: César Portocarrero

Over the years the tunnel developed numerous leaks, which prompted the Glaciology Unit to strengthen the drainage tunnel with concrete in 1974. The Unit also built a reinforced 10-meter-high earth dam above the tunnel to counteract possible glacier wave surges caused by avalanches or landslides.

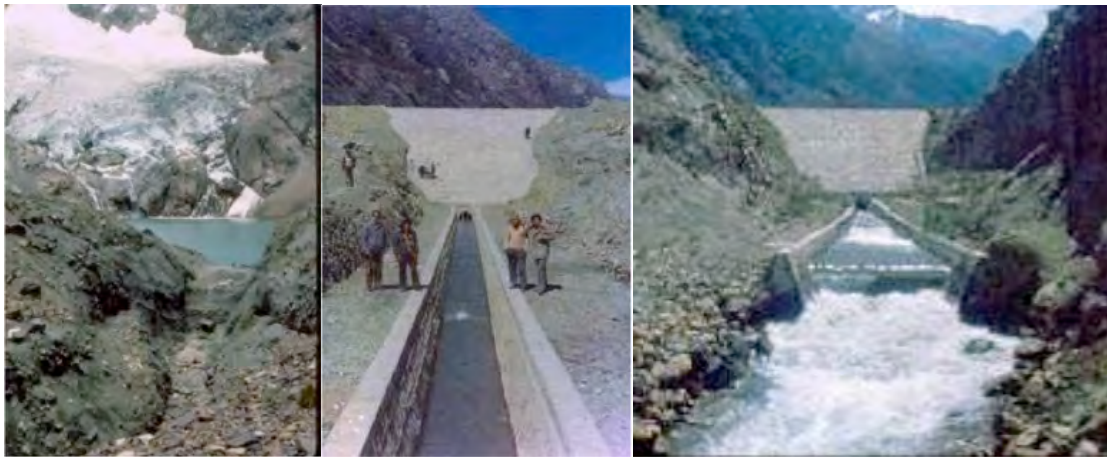
Constructing the Shallap Lake safety dam and water channel in 1973 and the completed work in 1974. Photos: César Portocarrero

holding 4.7 million m³ of water. The natural dam consisted of two high lateral moraines and a lower terminal moraine where the 4-meter-high dam had been built. In 1972–1974 the Glaciology Unit lowered the water surface by 10 meters and built an 80-meter-long covered passage, including a steel pipe beneath an earth dam and masonry channels. As in other cases, the artificial dam was built with a waterproof core and masonry walls.

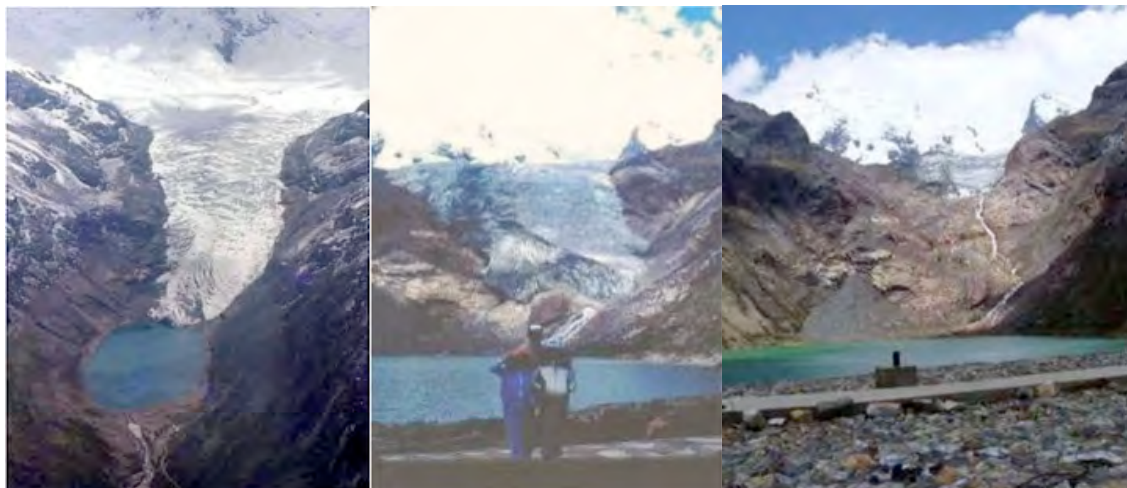
The retreating glacial tongue above Shallap Lake in 1974, 1980, and 2010. Photos: César Portocarrero

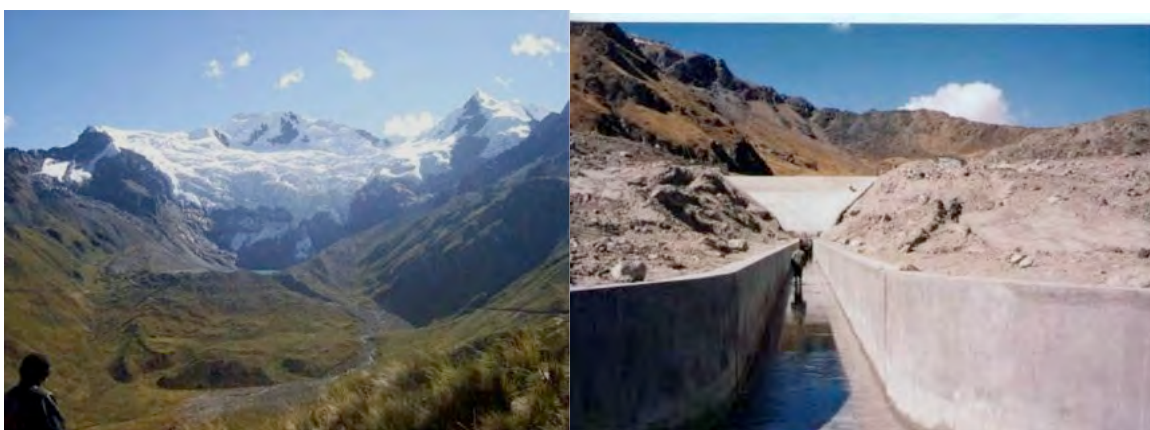
Lazo Huntay Lake showing the still-massive hanging glacier in 1990, and the newly completed safety works in 1990. Photos: César Portocarrero

In 1977, the Glaciology Unit initiated work (with support from The National Institute of Civil Defense of Peru) to partially drain the lake. Then, in early 1990, the Glaciology Unit recommenced work to complete the project by further lowering the water level, building an exhaust duct, and installing a dam.

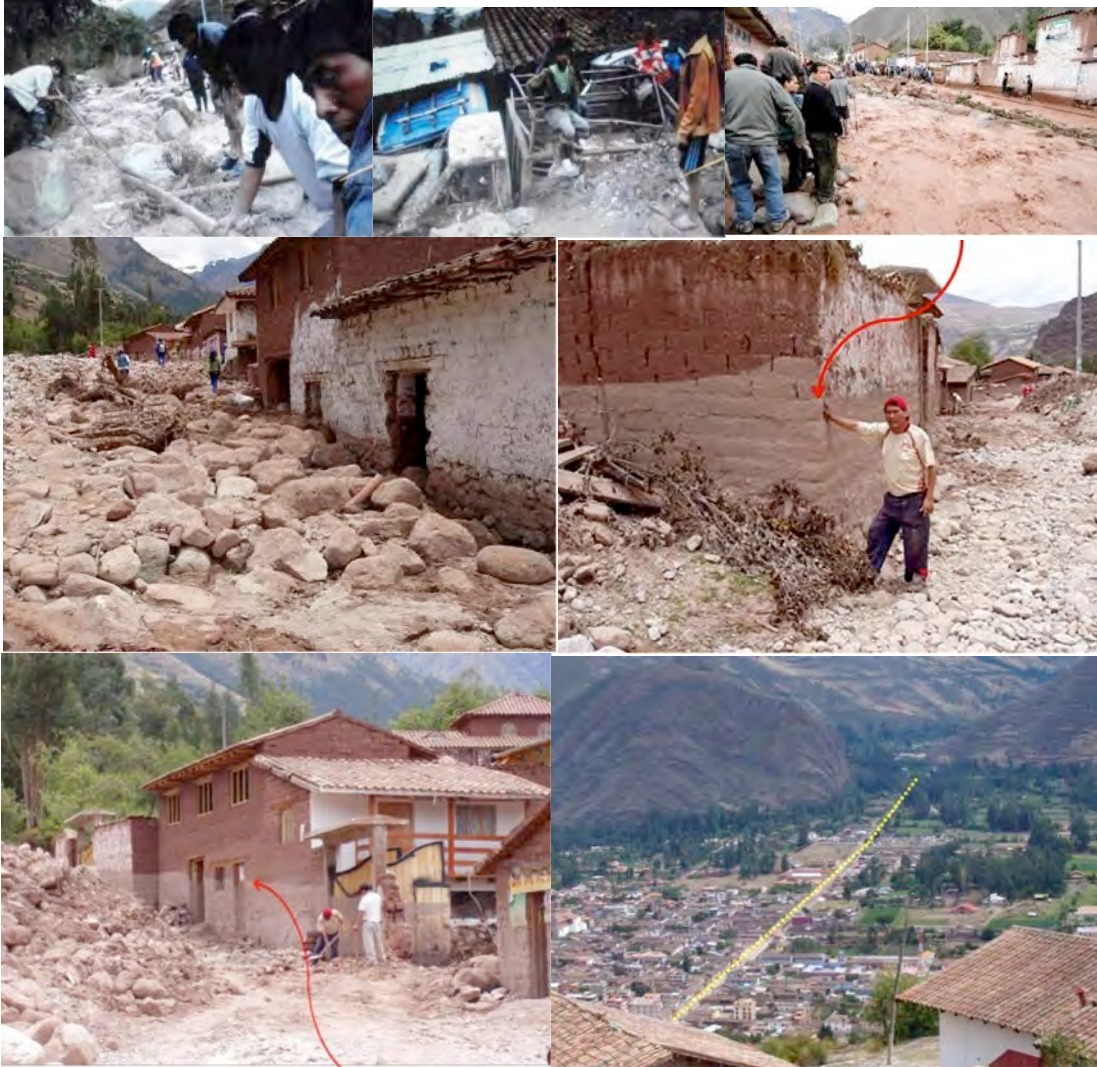
Top row: Photos from the flood of the Chicón River in San Isidro and Urubamba resulting from the Riticocha GLOF on 17 October 2010. Middle row: Debris and flood lines on walls in Urubamba in 2010. Lower right: The path the Chicón River took through Urubamba in 2010. Top row photos: Municipality of Urubamba. Other photos: César Portocarrero

On October 17, 2010, a large flash flood of the Chicón River damaged small towns as the water descended to the city of Urubamba. Investigations revealed that the flash flood was a GLOF from a new lake that had appeared at the foot of the Chicón Glacier: Riticocha Lake. Videos taken from helicopters revealed blocky fragments of ice on rock walls near the lake, indicating that one or more large waves had deposited them. It appeared that an original mass of water had triggered a second, lower lake to also be partially emptied.

Such heavy destruction leads scientists from the Cusco Civil Defense to believe that the volume of the GLOF was larger than the volume of the present lake. Clues include the magnitude and size of transported rocks, the volume of debris, and the boulders that reached the town of Urubamba. The floodwater's destructive power was increased by recent road building activities. Construction had loosened the earth and construction debris, including broken tree trunks, had been dumped into the riverbed.

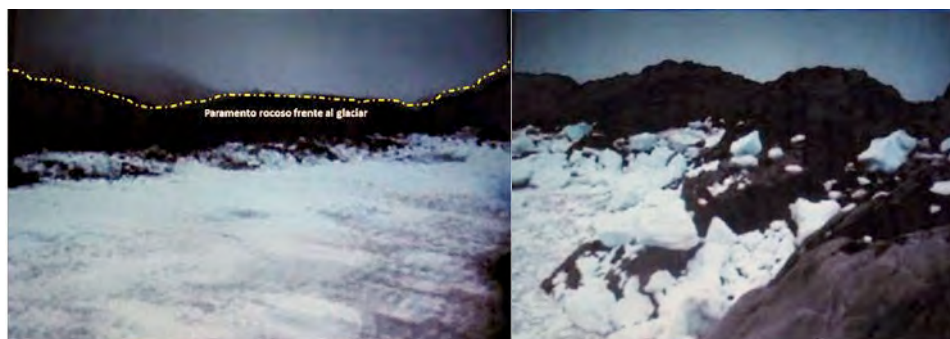
Waves deposited these large ice fragments high on Riticocha's rock walls. These photographs were taken a few days after the event and were taken during daylight, but are dark because it was captured from video. The dashed yellow line indicates the edge of the glacier. Photos: Urubamba Civil Defense
